# MICROCHIP PIC12(L)F1822/PIC16(L)F1823

## PIC12(L)F1822/PIC16(L)F1823 Family Silicon Errata and Data Sheet Clarification

The PIC12(L)F1822/PIC16(L)F1823 family devices that you have received conform functionally to the current Device Data Sheet (DS41413C), except for the anomalies described in this document.

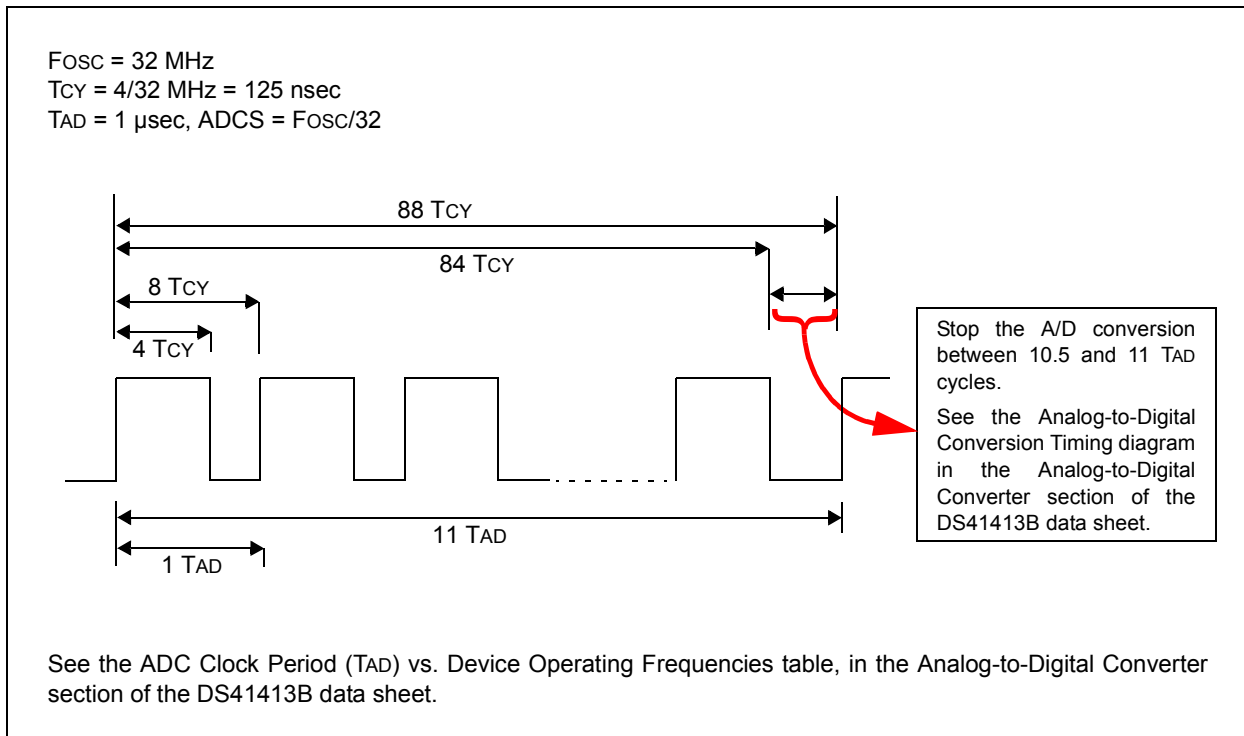
**FIGURE 1: INSTRUCTION CYCLE DELAY CALCULATION EXAMPLE**

Under certain device operating conditions, the ADC conversion may not complete properly. When this occurs, the ADC Interrupt Flag (ADIF) does not get set, the  $\overline{\text{GO/DONE}}$  bit does not get cleared and the conversion result does not get loaded into the ADRESH and ADRESL result registers.

In [Figure 1](#), 88 instruction cycles (TCY) will be required to complete the full conversion. Each TAD cycle consists of 8 TCY periods. A fixed delay is provided to stop the A/D conversion after 86 instruction cycles and terminate the conversion at the correct time as shown in the figure above.

**Note:** The exact delay time will depend on the choice of FOSC and the TAD divisor (ADCS) selection. The TCY counts shown in the timing diagram above apply to this example only. Refer to [Table 3](#) for the required delay counts for other configurations.

Method 1: Select the dedicated RC oscillator as the ADC conversion clock source, and perform all conversions with the device in Sleep.

Method 2: Provide a fixed delay in software to stop the A-to-D conversion manually, after all 10 bits are converted, but before the conversion would complete automatically. The conversion is stopped by clearing the  $\overline{\text{GO/DONE}}$  bit in software. The  $\overline{\text{GO/DONE}}$  bit must be cleared during the last  $\frac{1}{2}$  TAD cycle, before the conversion would have completed automatically. Refer to [Figure 1](#) for details.
