Stellaris® LM4F232H5QD Rev A1/A3/B0 Errata

Note: The Stellaris LM4F232H5QD microcontroller has been replaced by the identical Tiva™ C Series TM4C123GH6PGE microcontroller.

This document contains known errata at the time of publication for the Stellaris LM4F232H5QD microcontroller, revisions A1, A3, and B0. Additional errata that applies to revisions A1, A3, and B0, as well as revisions following B0 can be found in *Stellaris® LM4F Microcontrollers Silicon Revisions 6 and 7 Errata (SPMZ856)*. Read both documents for a complete list of errata for your device.

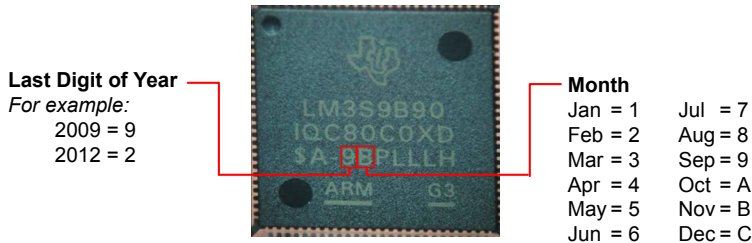
Note: To determine the date code of your part, look at the first two characters following the dash on the third line of the part markings (highlighted in red in the following figure). The first number after the dash indicates the last decimal digit of the year. The second character indicates the month. Therefore, the following example shows a date code of 9B which indicates November 2009.
