## PIC16F88X Family Silicon Errata and Data Sheet Clarification

The PIC16F88X family devices that you have received conform functionally to the current Device Data Sheet (DS41291G), except for the anomalies described in this document.

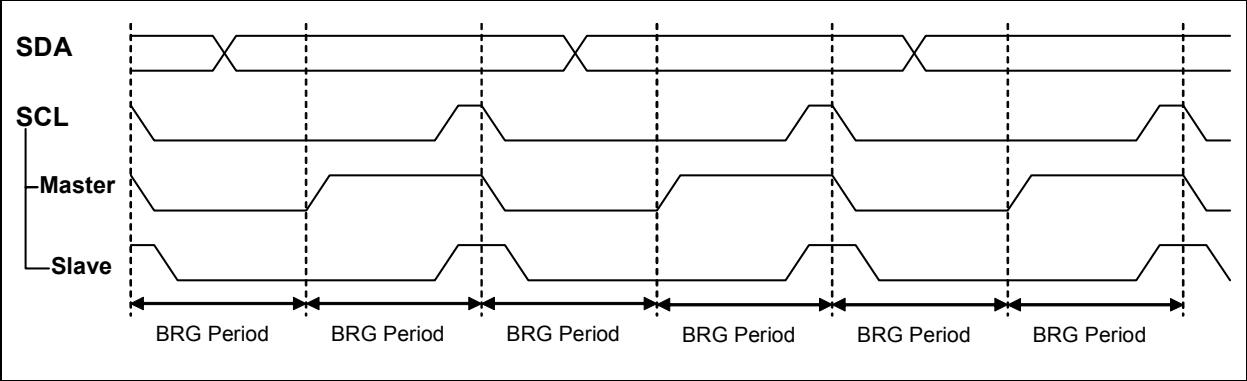
FIGURE 3: ACTUAL (INCORRECT) OPERATION WITH CLOCK STRETCHING – EXAMPLE 1

The current implementation does not ensure accurate SCL high time. During clock stretch, the MSSP device will erroneously continue running the BRG counter. At the end of the clock stretch the BRG counter continues to count down for the

remainder of the BRG period, and then the MSSP device will immediately resume transmitting the data.

Figure 3 and Figure 4 illustrate an actual I<sup>2</sup>C transmission in which the slave has stretched the clock period by holding the SCL line low. Note that the high time of the SCL signal has shortened from the expected time.

Set the communication speed to match the slowest device on the bus. This ensures that no slave device will perform clock stretching.

It is possible to dynamically adjust the communication speed to match the device being addressed by modifying the BRG register. However, the behavior of slower slave devices must be understood and speed adjustments made such that no slave performs clock stretching.
